# Manhole Inspection Summary

Manhole # S35MM1014MH

**Location** Address: **4505 UNDERWOOD RD**

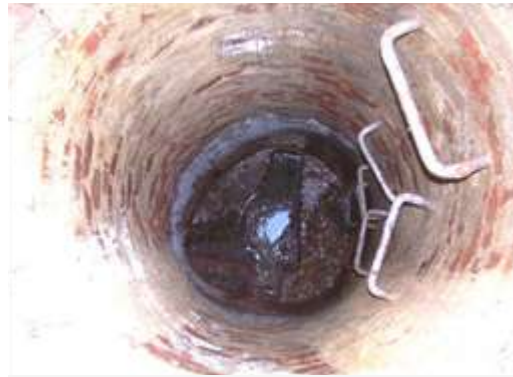
Top View

Corroded steps. Bench debris.

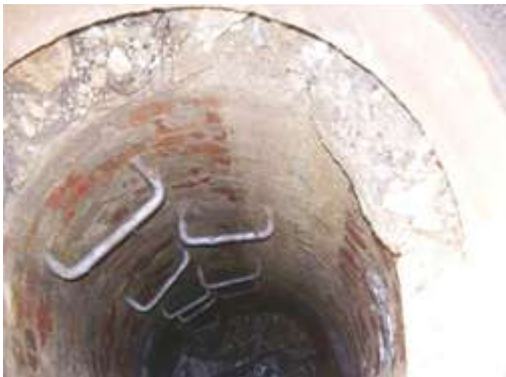
Defect

☒ **Leaks**

Condition: ☐ Sound ☐ Cracked ☐ Root Intrusion ☒ **Loose Brick** ☒ **Deteriorated**

Infiltration: ☐ None ☒ **Joint** ☐ Cracks ☐ Mortar ☐ Roots ☒ **Wall**

Frame leaks. Frame offset. Adjustment deterioration, loose brick and infiltration. Corbel and Barrel infiltration.

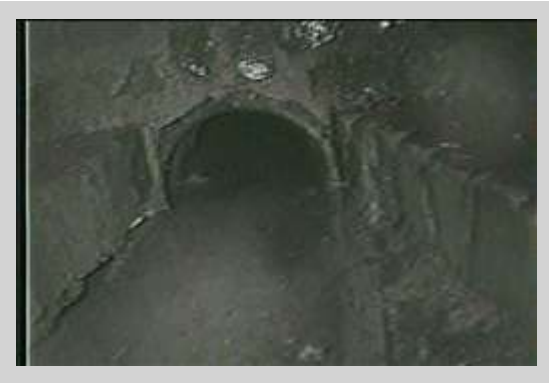
### 8 in. Circular Gravity Sewer Pipe Out @ 12 O'Clock

Condition: ☐ Sound ☐ Cracked ☐ Root Intrusion ☒ **Deteriorated** ☐ Leaks ☐ Debris

Channel deterioration.

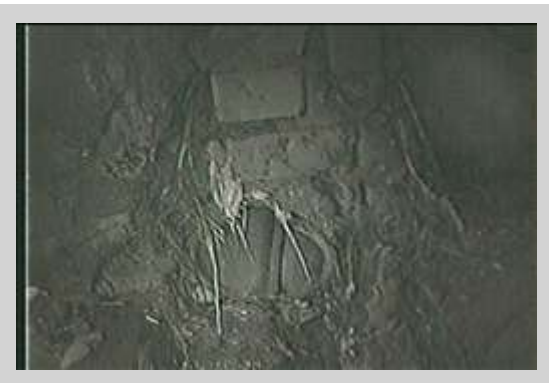
### 6 in. Circular Gravity Sewer Pipe In @ 6 O'Clock

Condition: ☐ Sound ☐ Cracked ☒ **Root Intrusion** ☐ Loose Brick ☒ **Deteriorated**

Infiltration: ☐ None ☐ Joint ☐ Cracks ☒ **Mortar** ☒ **Roots** ☒ **Wall**

Barrel root intrusion and infiltration.

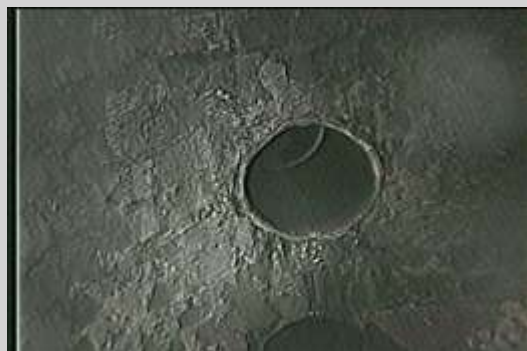
Pipe In @ 9 O'Clock

Barrel deterioration and infiltration.

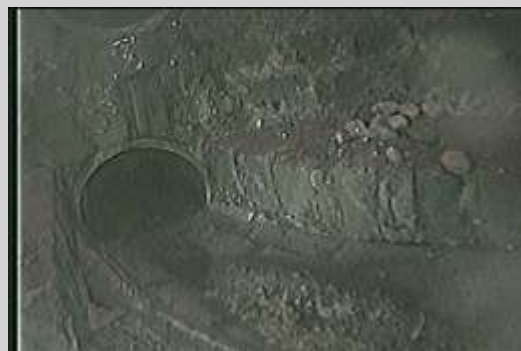
Drop In @ 9 O'Clock

Drop Condition: **Partly Clogged**
